# OLD DUCHY PALACE, LOSTWITHIEL, CORNWALL DENDROCHRONOLOGICAL ANALYSIS OF OAK TIMBERS

SCIENTIFIC DATING REPORT

NGR: SX 1048 5972

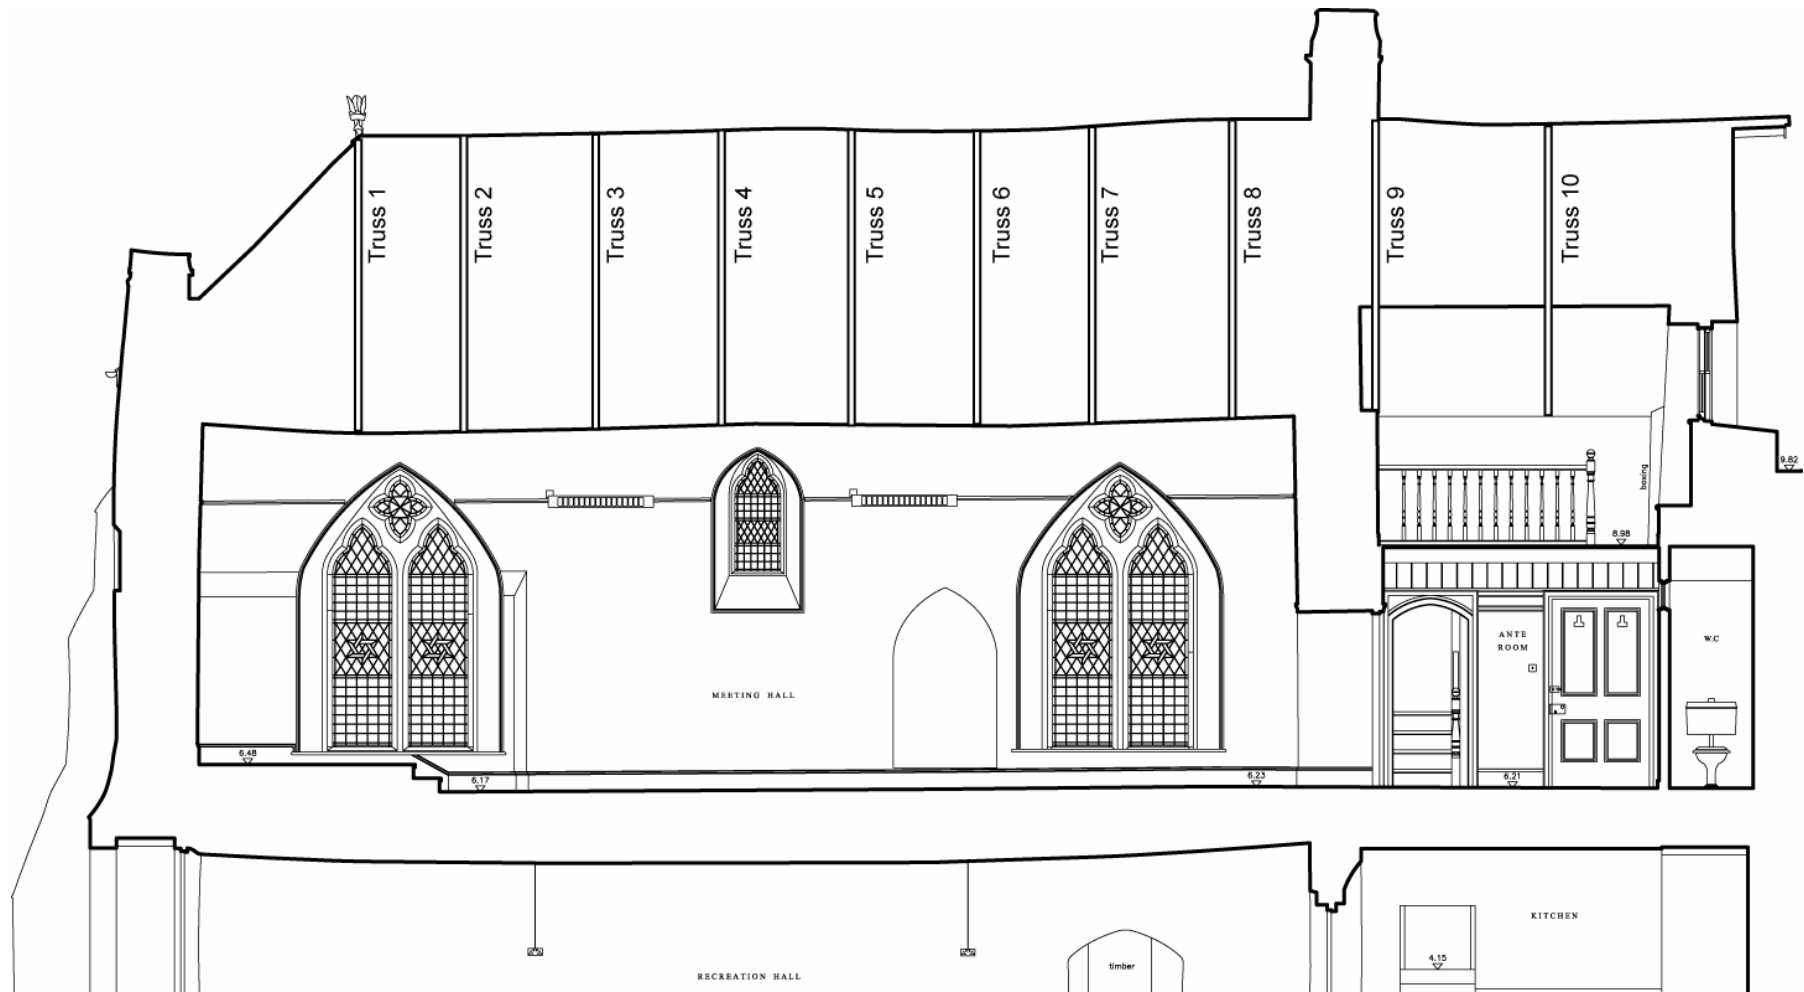
Figure 2. Longitudinal section through the Old Duchy Palace, looking east, with approximate location of the roof trusses (T1–T10) (based on a drawing by Purcell Miller Tritton LLP)

In January 2009 10 timbers of the roof were cored; these cores were labelled 1–10 inclusive (Figs 2–5). Each sample was assessed for the wood type, the number of rings it contained, and whether the sequence of ring widths could be reliably resolved. This assessment confirmed that all the sampled timbers were oak (*Quercus* spp.) and that all were suitable for dendrochronological analysis. There was good survival of sapwood in the roof. The details of these samples are provided in Table 1.

The roof comprises 10 trusses (Fig 2). These simple A-trusses have non-diminished principal rafters, straight collars with bare-faced dovetails lapped onto the principal rafters, a diamond set threaded ridge, and three rows of threaded purlins. The principal rafters were derived from fairly slow-grown oak trees c 300mm in diameter. Each principal rafter was probably halved, although some may have been slabbed into four. Along most there was usually some surviving sapwood. Visual inspection suggested that it was likely that the principal rafter pairs in each truss were derived from a single tree. The trusses were mostly arranged with the outermost faces of the oaks facing outermost faces on the adjacent trusses, and the innermost faces likewise, so that the trusses have alternating alignments. Trusses T9 and T10 are south of a large chimney stack. These have a different spacing and have a different ceiling height below them. Nevertheless, they are of identical original form, although they now have some later strengthening elements added to them, and the lower ends are boxed in. Samples from these two trusses were taken to check they were not a different construction date. The wall plates, purlins, and collars of the whole roof were also oak timbers, but in these elements either the timbers contained relatively few rings, or elements like the lower purlins and wall plates were inaccessible. The main roof section, trusses T1–T8, had been extensively modified to suspend a ceiling for the hall below. These elements are softwood and probably date from the nineteenth or twentieth century.
